Heat Exchanger Failure Analysis

A Gulf Coast refinery experienced failures of two admiralty depropanizer heat exchangers after 28 years of service and failures of replacement carbon steel heat exchangers after only ten months of service. The admiralty corrosion rate has consistently exceeded the maximum specification rate of 0.2 mpy during the last two years of service.

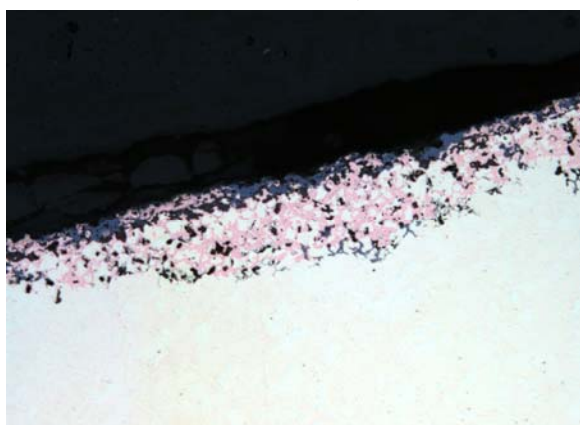
Figure 1 – Cross Section of Tube Wall of Admiralty Heat Exchanger

Examination of the failed section of the admiralty bundles showed extensive under-deposit corrosion. (Figure 1)

Our investigation identified high concentrations of suspended solids as the source of deposits on the heat transfer surfaces. Concentration of acidic species, especially chlorides, caused corrosion under the deposits. Poor chlorination practices deactivated the copper corrosion inhibitor and exacerbated the copper corrosion rate.

To reduce the risk of additional failures, MarTech recommended that refinery personnel optimize the clarification process for the make-up water to reduce the concentration of suspended solids, change the feed protocol for chlorine and azole to minimize deactivation of the copper corrosion inhibitor and initiate an off-line passivation procedure for new carbon steel heat exchangers.

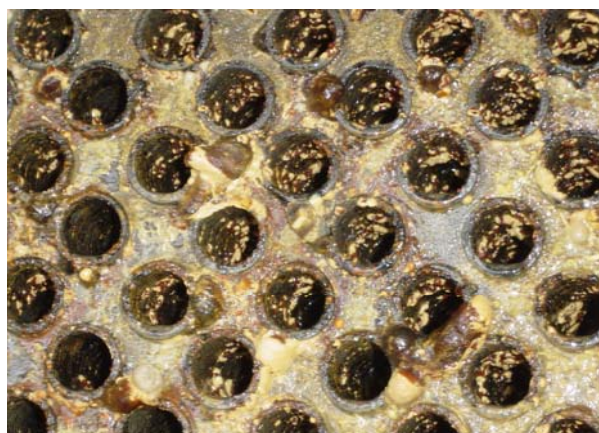
Figure 2 – Tubesheet of Carbon Steel Heat Exchanger

The corrosion rate in the carbon steel heat exchangers was very high, creating tubercles on the tubesheet (Figure 2) and the heat transfer surfaces.

A review of the ten-month operating history and conformance to specification limits for water quality indicated that a process leak occurred immediately after installation of the carbon steel heat exchangers, before in-situ passivation occurred.
