Audit of Comfort System Water-related Utilities

A Northeastern facility had several issues, including odor in the potable water, high rates of corrosion in the cooling water circuit and concern about risk of exposure of facility personnel to *legionella* bacteria.

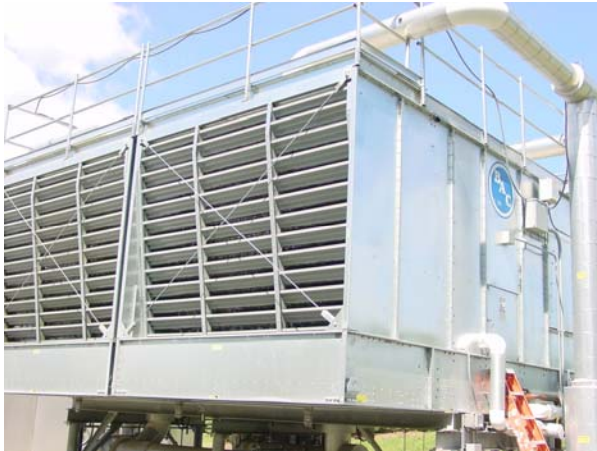
Figure 1 – Cooling tower

Our review of the condenser water circuit (Figure 1) indicated that the use of softened water as make-up was causing high rates of carbon steel corrosion, compromising the system reliability.

Following our audit, facility staff removed all “dead leg” piping and plan to isolate the fire sprinkler circuit from the potable water circuit to eliminate stagnant water. MarTech recommended eliminating the use of softened water for cooling tower make-up and potable supplies. MarTech also recommended modifying the tower maintenance procedures to reduce the risk of exposure of personnel to aerosols that might contain *legionella* bacteria.

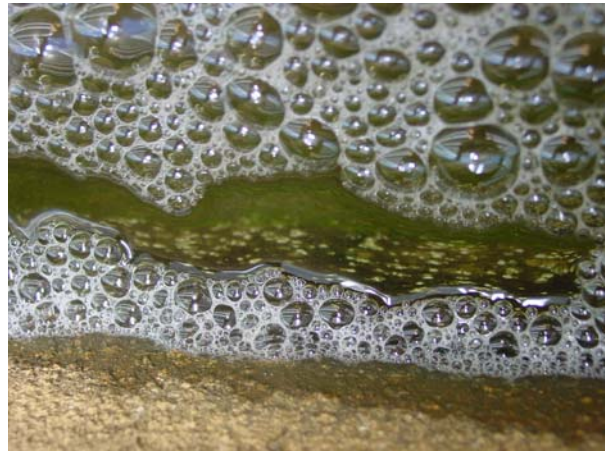
Our review of the risk of exposure of facility personnel to *legionella* identified basin cleaning activities that generate aerosol particles of cooling water as the event of highest risk. Figure 2 shows the sediment in the basin.

Figure 2 – Sediment in Cooling Tower Basin
